TOOLBOX SAFETY TRAINING

Volume 13 - Number 36 ELECTRICAL FACE PLATES

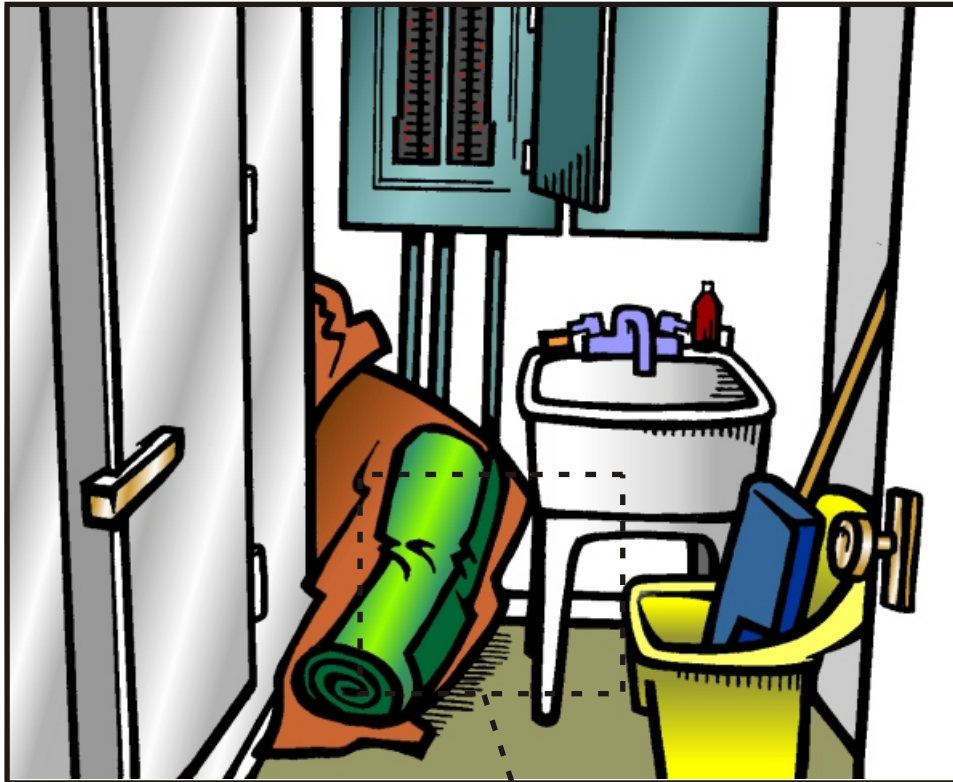
A routine inspection of a company office found this electrical hazard lurking in a back utility room. An electrical outlet that was missing a face plate was located directly under a sink, exposing the wires to possible wet conditions. The outlet was covered by boxes and dirty carpets.

This is an electrical fire hazard waiting to happen.

FIRE HAZARD-
Electrical box was left without a face plate and dirty carpets and boxes were put over it.

Always make sure that electrical boxes are properly covered and clear of debris. Don't take chances with electricity.

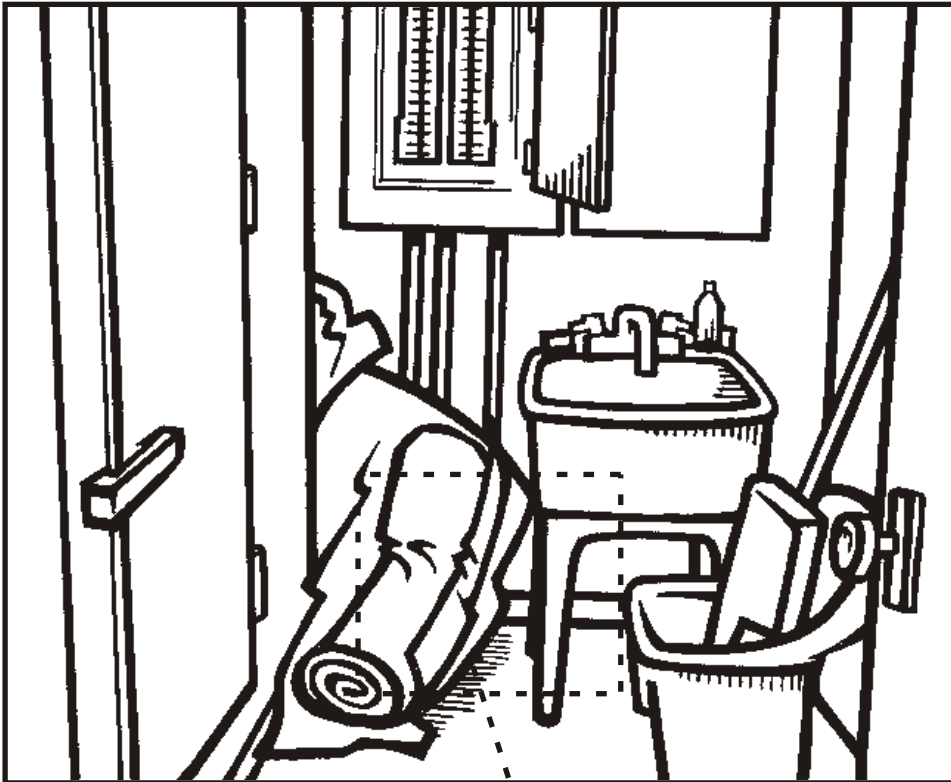
A routine inspection of a company office found this electrical hazard lurking in a back utility room. An electrical outlet that was missing a face plate was located directly under a sink, exposing the wires to possible wet conditions. The outlet was covered by boxes and dirty carpets.

This is an electrical fire hazard waiting to happen.

FIRE HAZARD-
Electrical box was left without a face plate and dirty carpets and boxes were put over it.

Always make sure that electrical boxes are properly covered and clear of debris. Don't take chances with electricity.
